Corvette Central .com
800-345-4122

INSTALLATION INSTRUCTIONS

PART NO. 281014 SHEET 1 OF 1

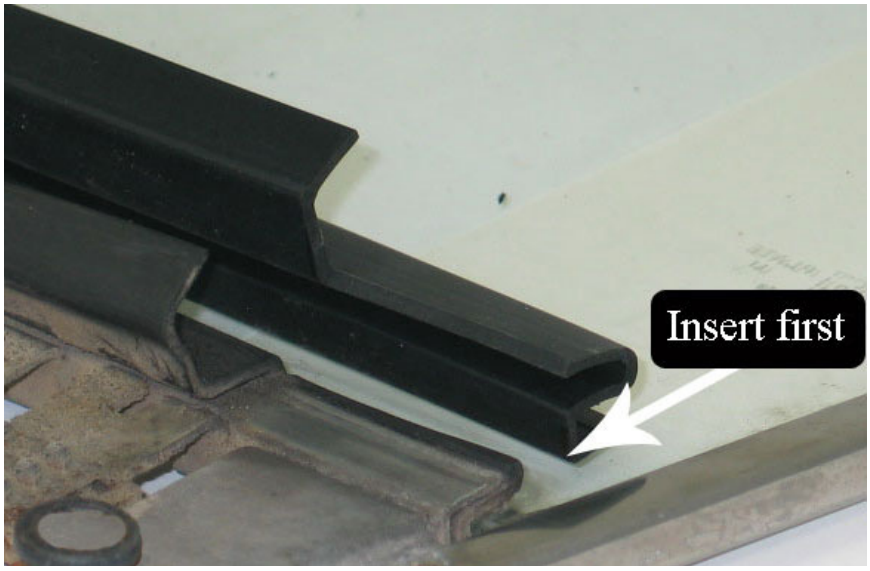
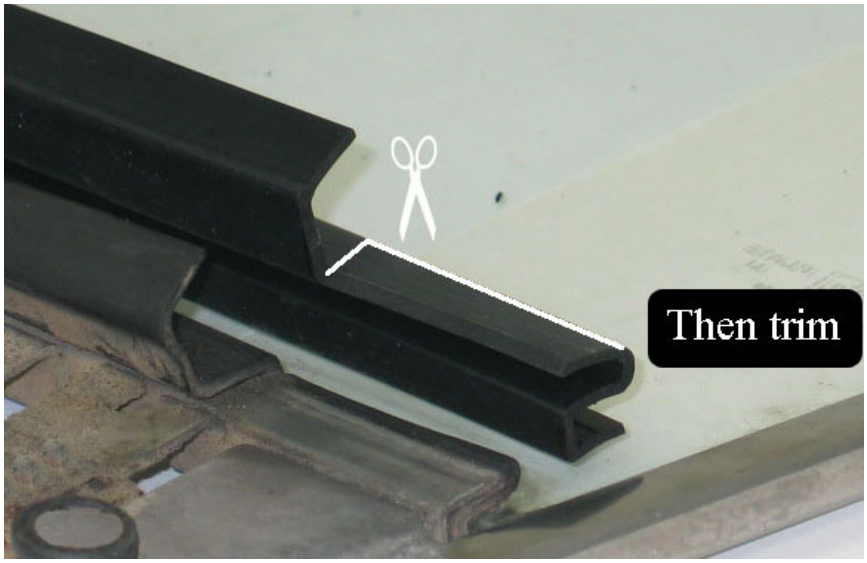
Due to minor distortion of the rubber on the lower seal during assembly, it is recommended to assemble the side window and trim the front portion of the seal. Using an exacto knife, box cutter or utility knife trim the front portion of the seal even with the “U” channel to match the existing notch. This will avoid interference with the front roller channel.
